**USEPA – Region 6, Dallas, Texas
Superfund Site Inspection Report
Hurricane Harvey Follow-up**

Site: San Jacinto River Waste Pits **Location:** Channelview, Texas **Date of Inspection:** 9/4/2017

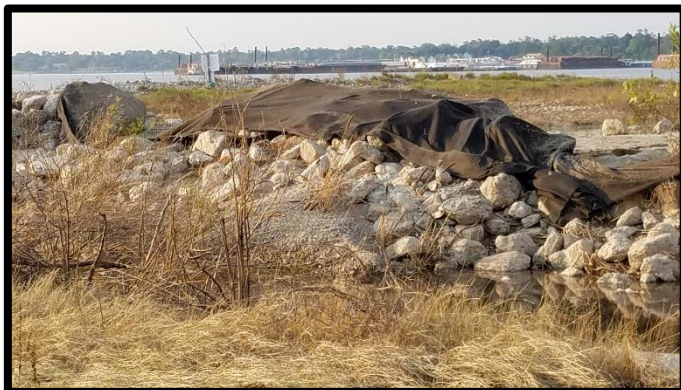
San Jacinto River Waste Pits
Eroded stone & fabric on West of south berm
View: Northeast Date: 9/3/2017
Coordinates: Lat: +29.794400
Long: -95.062500

- Repair fencing to secure site.
- Perform repairs of armor cap.
- Recover, repair, and replace site buoy system.
- Collect sediment & surface water samples to confirm no release.
- Perform topographic & bathymetric surveys to assess all of cap.
- Perform manual probing as an additional means of assessing cap condition.
- Utilize EPA Dive Team to assess underwater portions of cap and collect additional sediment samples from any underwater areas found with gaps in the cap.
- Replace/repair site warning signs.

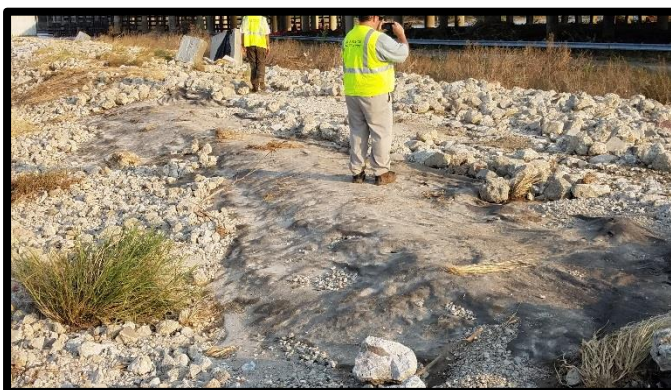
San Jacinto River Waste Pits
Stone eroded on East of south berm
View: East Date: 9/3/2017
Coordinates: Lat: +29.794400
Long: -95.062500
